# New Hampshire Volunteer Lake Assessment Program

## 2003 Biennial Report for Pine River Pond Wakefield

## Pine River Pond, Wakefield

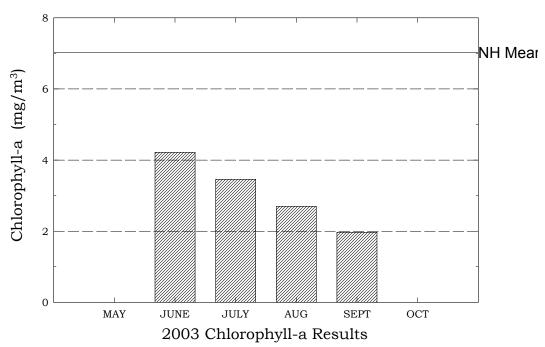
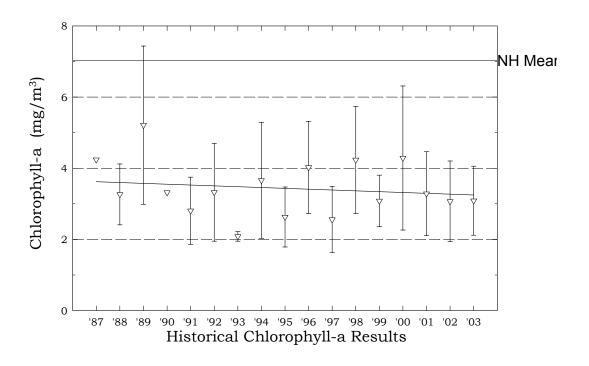
Figure 1. Monthly and Historical Chlorophyll-a Results

The current year data (the top graph) show that the chlorophyll-a concentration *decreased* from June to September. The chlorophyll-a concentration in all four months was *less than* the state mean.

The historical data (the bottom graph) show that the 2003 chlorophyll-a mean is *less than* the state mean.

Overall, the statistical analysis of the historical data (the bottom graph) shows that the mean annual chlorophyll-a concentration has **not significantly changed** (either *increased* or *decreased*) since monitoring began in **1987**. Specifically, the chlorophyll-a concentration has remained **relatively stable** and has been **less than** the state mean (Note: Please refer to Appendix E for the detailed statistical analysis explanation and data print out.)

While algae are naturally present in all lakes/ponds, an excessive or increasing amount of any type is not welcomed. In freshwater lakes/ponds, phosphorus is the nutrient that algae depend upon for growth. Algal concentrations may increase with an increase in nonpoint sources of phosphorus loading from the watershed, or inlake sources of phosphorus loading (such as phosphorus releases from the sediments). Therefore, it is extremely important for volunteer monitors to continually educate residents about how activities within the watershed can affect phosphorus loading and pond quality.

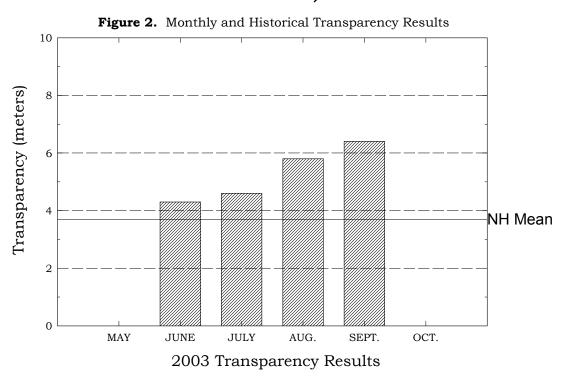
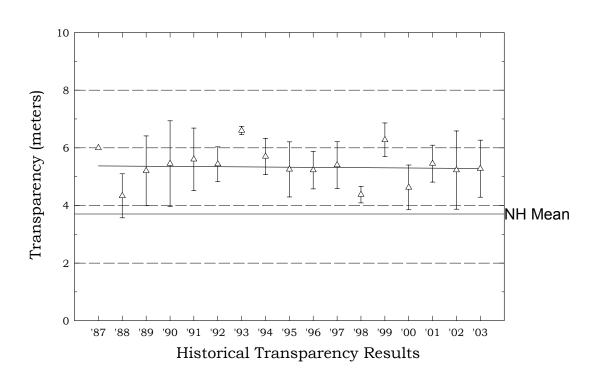
The current year data (the top graph) show that the in-lake transparency *increased* from June to September. The transparency in all four months was *greater than* the state mean.

The historical data (the bottom graph) show that the 2003 mean transparency is *greater than* the state mean.

It is important to note that as the chlorophyll concentration decreased from June to September, the transparency increased. We typically expect this inverse relationship in lakes. As the amount of algal cells in the water column decreases, the depth to which one can see into the water column typically increases.

Overall, the statistical analysis of the historical data (the bottom graph) show that the mean annual in-lake transparency has **not significantly changed** (either *increased* or *decreased*) since monitoring began in **1987**. Specifically, the in-lake transparency has remained **relatively stable** and has been **greater than** the state mean. (Note: Please refer to Appendix E for the statistical analysis explanation and data print out.)

Typically, high intensity rainfall causes erosion of sediments into lakes/ponds and streams, thus decreasing clarity. Efforts should continually be made to stabilize stream banks, pond shorelines, disturbed soils within the watershed, and especially dirt roads located immediately adjacent to the edge of tributaries and the pond. Guides to Best Management Practices designed to reduce, and possibly even eliminate, nonpoint source pollutants, such as sediment loading, are available from DES upon request.

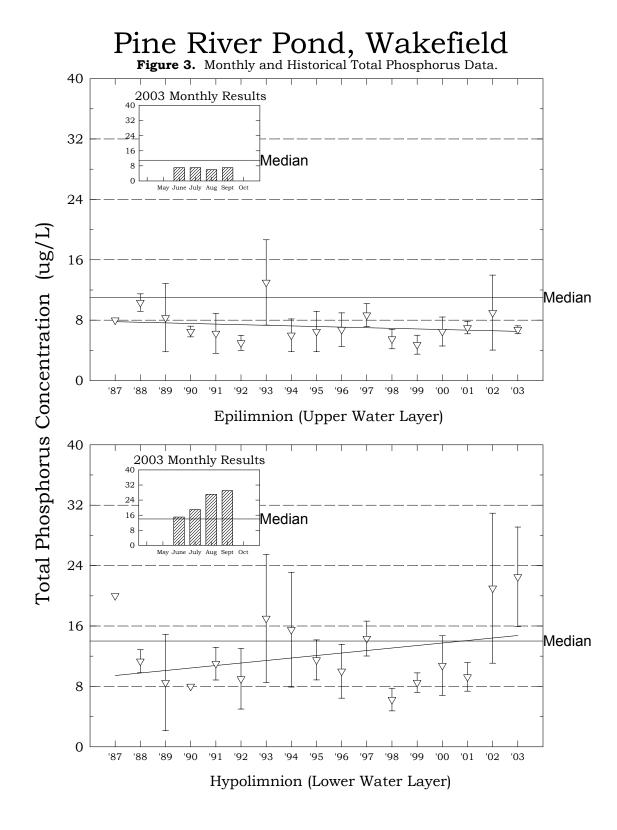
Figure 3 and Table 8: The graphs in Figure 3 (Appendix A) show the amounts of phosphorus in the epilimnion (the upper layer) and the hypolimnion (the lower layer); the inset graphs show current year data. Table 8 (Appendix B) lists the annual maximum, minimum, and median concentration for each deep spot layer and each tributary since the pond has joined the program.

The current year data for the epilimnion (the top inset graph) show that the phosphorus concentration **remained stable** from June to September. The phosphorus concentration in all four months was **less than** the state median.

The historical data show that the 2003 mean epilimnetic phosphorus concentration is *less than* the state median.

The current year data for the hypolimnion (the bottom inset graph) show that the phosphorus concentration *increased* from June to

September. The phosphorus concentration in all four months was *greater than* the state median.

The historical data show that the 2003 mean hypolimnetic phosphorus concentration is *greater than* the state median.

Overall, the statistical analysis of the historical data show that the phosphorus concentration in the epilimnion (upper layer) and the hypolimnion (lower layer) has **not significantly changed** (either increased or decreased) since monitoring began in **1987**. Specifically, the phosphorus concentration in the epilimnion and hypolimnion has remained **relatively stable** and has been **approximately equal to** the state median. (Note: Please refer to Appendix E for the statistical analysis explanation and data print out.)

One of the most important approaches to reducing phosphorus loading to a waterbody is to continually educate watershed residents about its sources and how excessive amounts can adversely impact the ecology and value of lakes and ponds. Phosphorus sources within a lake or pond's watershed typically include septic systems, animal waste, lawn fertilizer, road and construction erosion, and natural wetlands.
